Bay Networks

Part No. 116950-A Rev. A

Technical Notice

Corrections to *Installing and Operating BayStack ARN Routers*

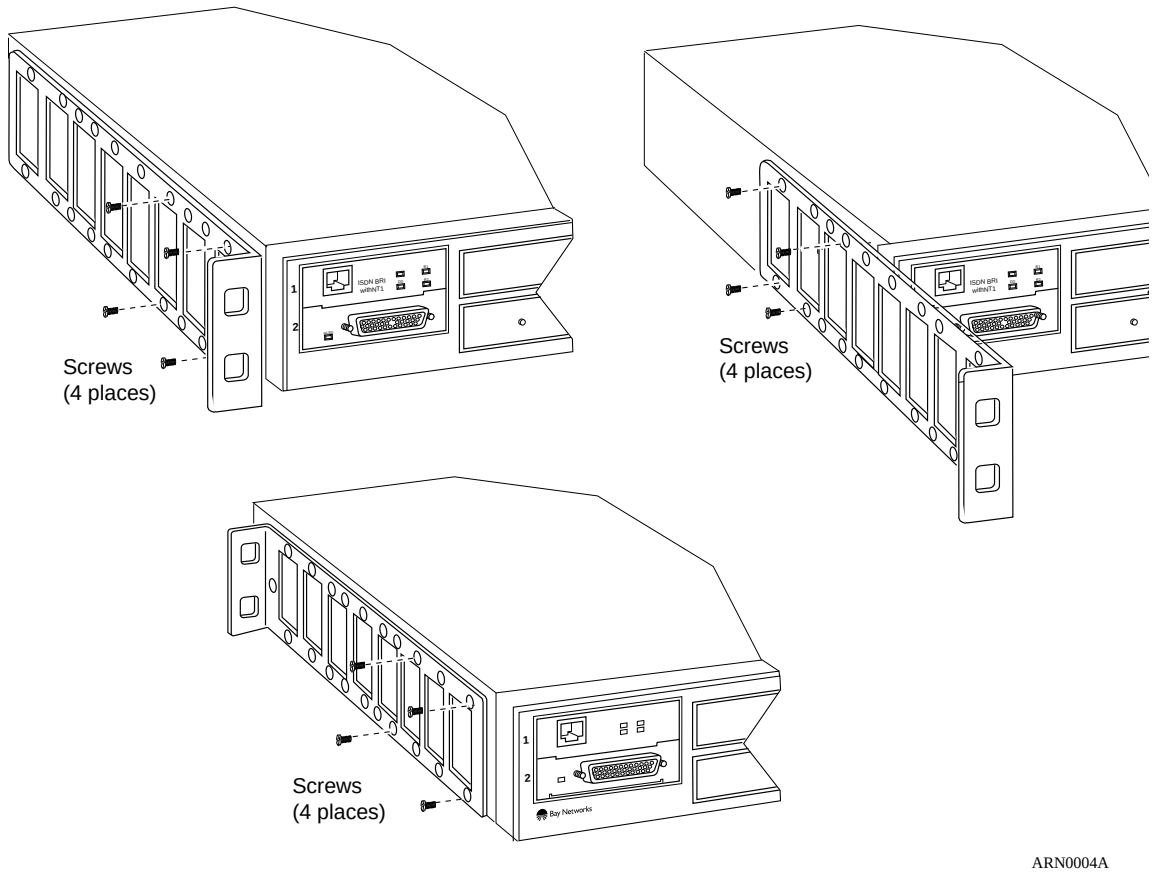
Figure 1. Attaching Brackets to Rack-Mount the ARN

The flange brackets for mounting the ARN in a rack now support additional rack positions. Figures 1-1 and 1-2 in *Installing and Operating BayStack ARN Routers* illustrate the wrong mounting bracket. Figure 1 correctly illustrates the options for attaching the new mounting brackets.
